DRILLING AND TEST PUMPING OF ONE BOREHOLE IN KAYUNGA

Borehole Completion Report

TGS 201840

TGS Water Ltd

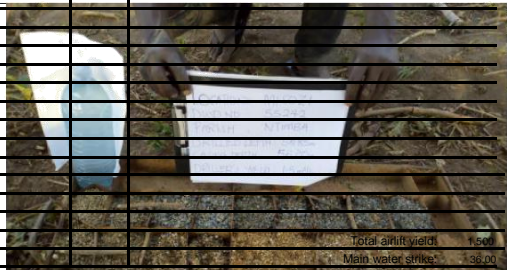
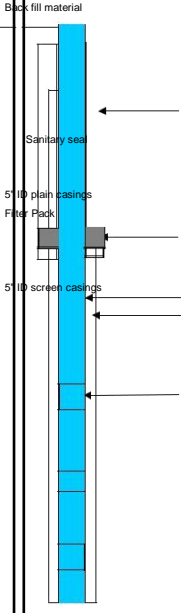
Annex 1: Borehole log

Drill pipe	Depth (m bgl)	Penetration rate (min/m)	Geology	Type	Size and color and other details	Design	Details / Remarks
1	1.87	5			Yellowbrown laterite		
1	2.37	2			yellow brown laterite		
2	4.37	11		loam	yellow brown laterite		
3	6.85	6			Rad brown laterite		
4	8.85	4			Yellow brown sticky clay		
5	10.85	2			Yellow brown sticky clay		
6	12.85	3			Yellow brown sticky clay		
7	14.85	3			Yellow brown sticky clay		
8	16.85	4			Yellow brown sticky clay		
9	18.85	6		Clay	Yellow brown sticky clay		
10	20.85	6			Yellow brown sticky clay		
11	22.85	11			Yellow brown sticky clay		
12	24.85	6			Yellow brown sticky clay		
13	26.85	7			Yellow brown sticky clay		
14	28.85	10			Yellow brown sticky clay		
15	30.85	6			Light brown sandy weathered rock		
16	32.85	5			Light brown sandy weathered rock		
17	34.85	6			Light brown sandy weathered rock	F 34.00	200
18	36.85	9		Weathered rock	Light brown sandy weathered rock		
19	38.85	13			Light brown sandy weathered rock

20	40.85	4			Light brown sandy weathered rock		
21	42.85	6			sandy weathered rock		
22	44.85	7			sandy weathered rock		
23	46.85	9			ite - medium grained granite	F 46.00	400
24	48.85	26			ite - medium grained granite		
25	50.85	45		Fresh b	ly medium grained granite	F 50.00	400
26	52.85	36			ly medium grained granite		
27	54.85	50			ly medium grained granite		
28	56.85	58			Medium gray medium grained granite		
29	58.85	67			Medium gray medium grained granite	F 58.00	300

Total airlift yield: 1.50
Main water strike: 38.00

Equipment	Length	Depth		ID	OD	Diameter and type
		2.9	0.00	38.34	127	139.7
1		38.34	41.27	127	139.7	5" ID screen casings
1		41.27	44.20	127	139.7	5" ID Plain casings
1		44.20	47.13	127	139.7	5" ID screen casings
1		47.13	52.99	127	139.7	5" ID Plain casings
1		52.99	55.92	127	139.7	5" ID screen casings
1		55.92	58.85	127	139.7	5" ID Plain casings

Annular space	Depth		Volume (l)	Fill type
		16.00	530	Inert backfill
		16.00	176	Cement grout
	18.00	62.87	460	Filter Pack

Design; The borehole was installed to 56.20 m with 5" ID Plain and screen casings from top bottom.

The borehole was drilled to a depth of 58.85m with registered water strike levels at 36m, 42m having yields of 1000/hr and 400 l/hr respectively during drilling.

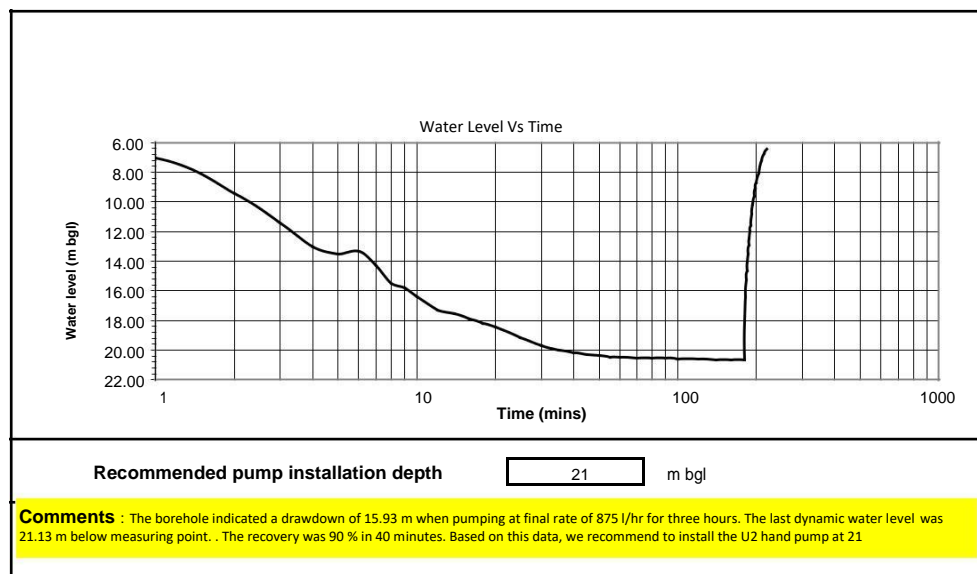
Annex 2: Test pumping results

DRAWDOWN			
Time, t (mins)	Water Level (m bgl)	Drawdown (m)	Discharge, Q (l/h)
0	4.53	0.22	
1	7.05	2.30	1600
2	9.41	4.66	
3	11.40	6.65	1150
4	13.02	8.27	
5	13.52	8.77	
6	13.32	8.57	
7	14.29	9.54	
8	15.50	10.75	
9	15.80	11.05	1000
10	16.40	11.65	
12	17.27	12.52	
14	17.55	12.80	
16	17.89	13.14	
18	18.17	13.42	
20	18.46	13.71	916
25	19.14	14.39	
30	19.71	14.96	
35	20.00	15.25	
40	20.15	15.40	
45	20.31	15.56	
50	20.38	15.63	
55	20.45	15.70	
60	20.47	15.72	897
70	20.53	15.78	
80	20.55	15.80	
90	20.56	15.81	
100	20.57	15.82	
120	20.61	15.86	
140	20.63	15.88	
160	20.64	15.89	875
180	20.68	15.93

RECOVERY			
Time, t (min)	Time (min)	Water Level (m)	Residual Drawdown (m)
0	180	20.68	15.93
1	181	18.15	13.40
2	182	16.40	11.65
3	183	15.27	10.52
4	184	14.65	9.90
5	185	14.05	9.30
6	186	13.49	8.74
7	187	12.93	8.18
8	188	12.50	7.75
9	189	11.97	7.22
10	190	11.60	6.85
12	192	10.80	6.05
14	194	10.17	5.42
16	196	9.60	4.85
18	198	9.09	4.34
20	200	8.69	3.94
25	205	8.05	3.30
30	210	7.23	2.48
35	215	6.76	2.01
40	220	6.42	1.67
45	225		
50	230		
55	235		
60	240		
70	250		
80	260		
90	270

The borehole was subjected/ pumped for 3hrs at 0.90 m³/hr constant rate (CR) test and the water level was drawn to 20.68 mbgl. It showed a recovery of 90% in 40mins. The detailed test pumping data is presented in Annex 2.
